Danish Maritime Accident
Investigation Board

MARINE ACCIDENT REPORT

AARSLEFF JACK III / WESTSUND / JOHANNA
Breakdown and collision on 18 December 2011

Joint investigation report by the flag State of the United Kingdom and the flag State of Denmark in accordance with the IMO Casualty Investigation Code (resolution MSC.255(84))

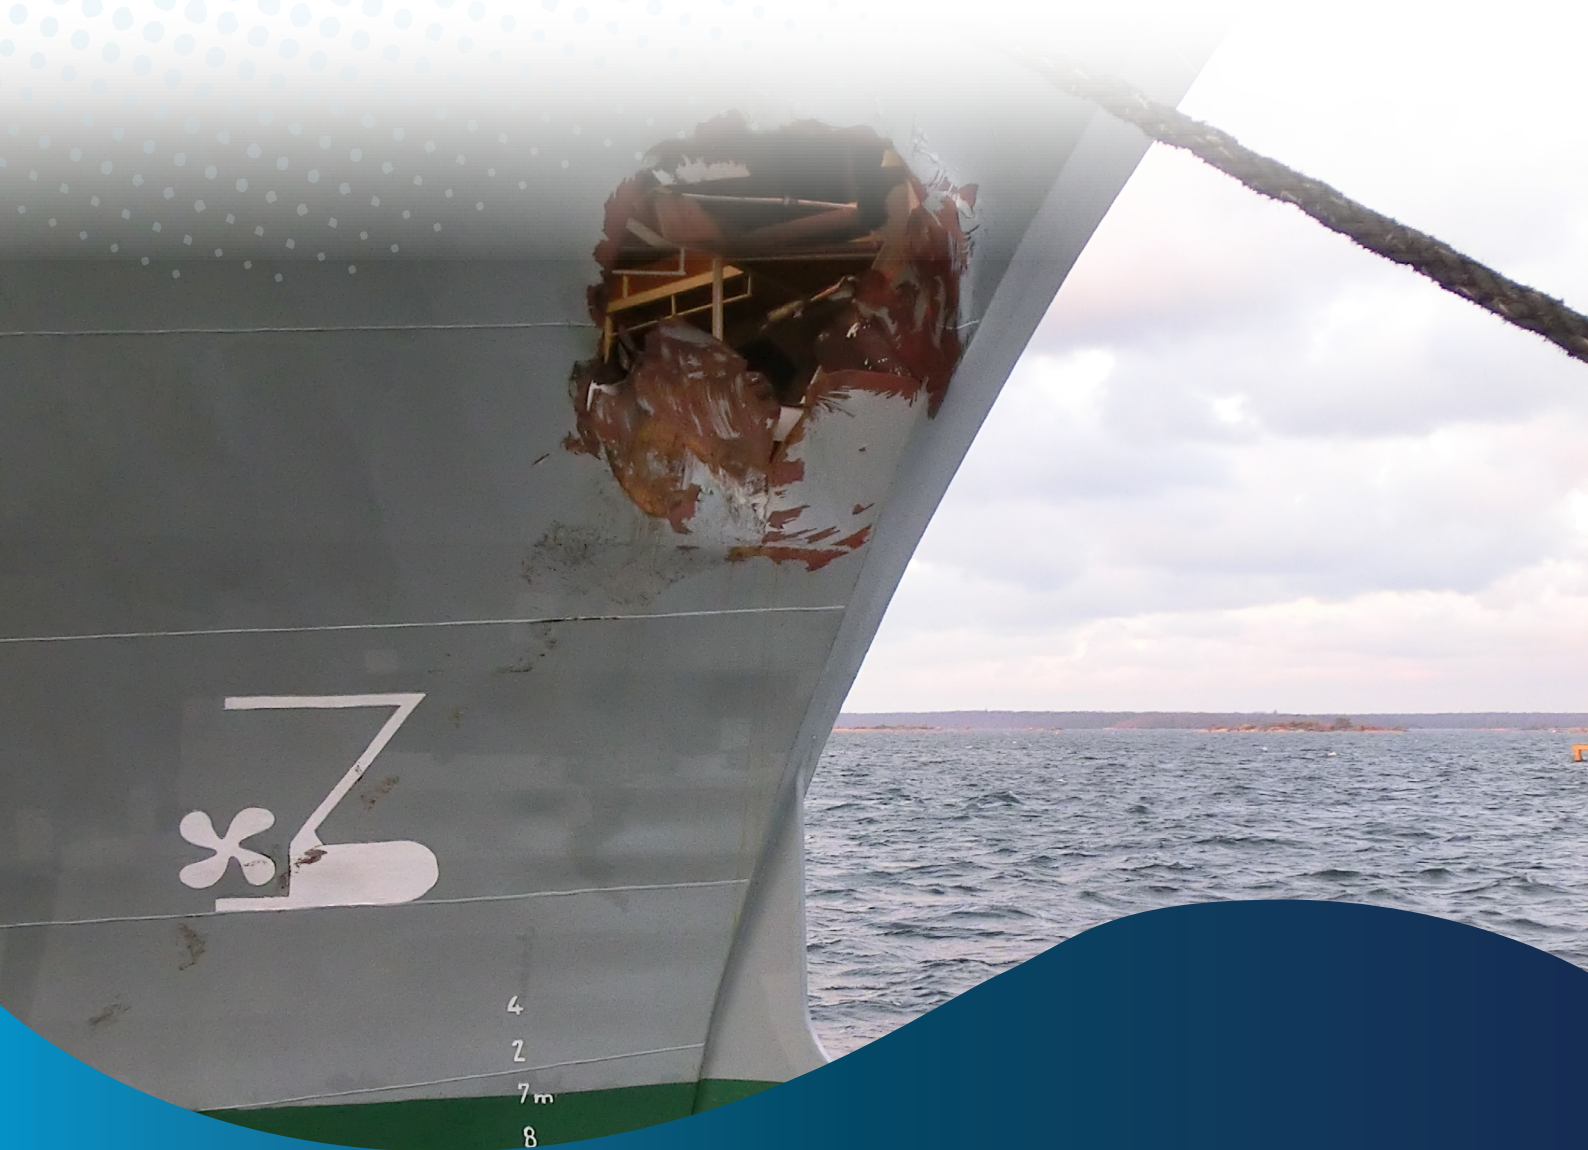
Front page: Damage to the hull of JOHANNA, MAIB.

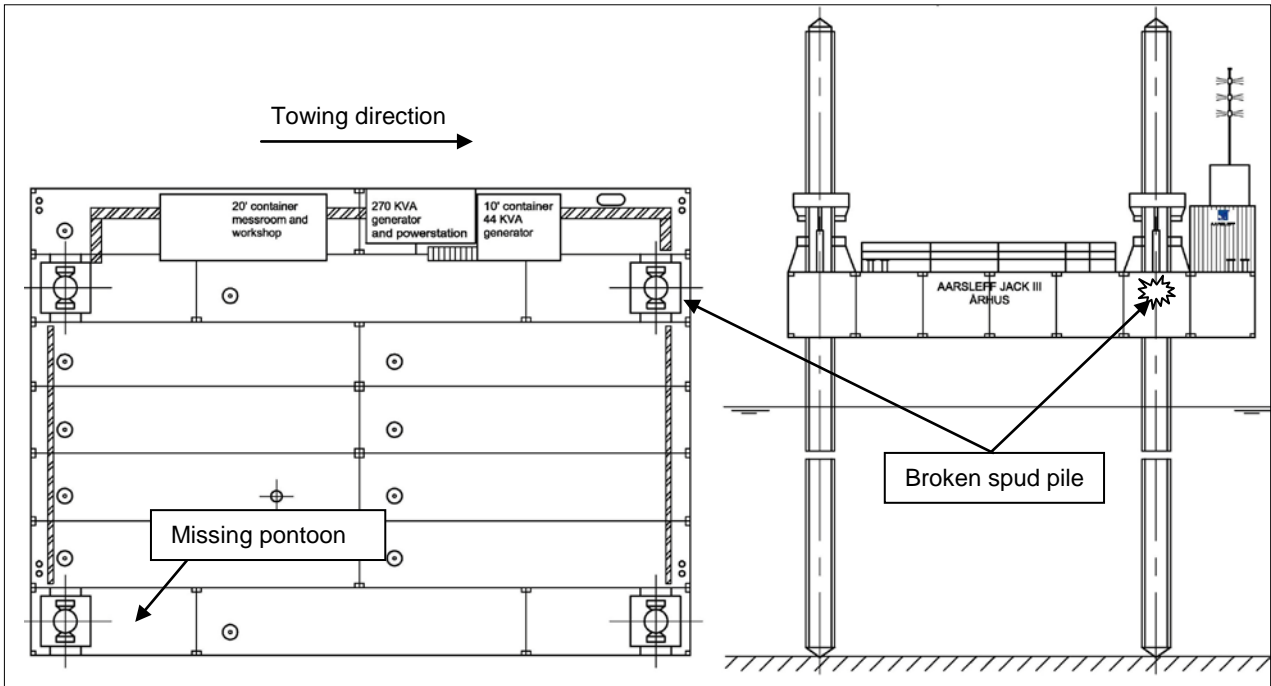
Figure 9: Layout of AARSLEFF JACK III
Source: Aarsleff A/S

The barge had mainly suffered damage to the spud pile and jack-up unit on the forward part on the port side and the pontoon on the aft starboard side that was missing. See the layout of the barge in figure 9 below.

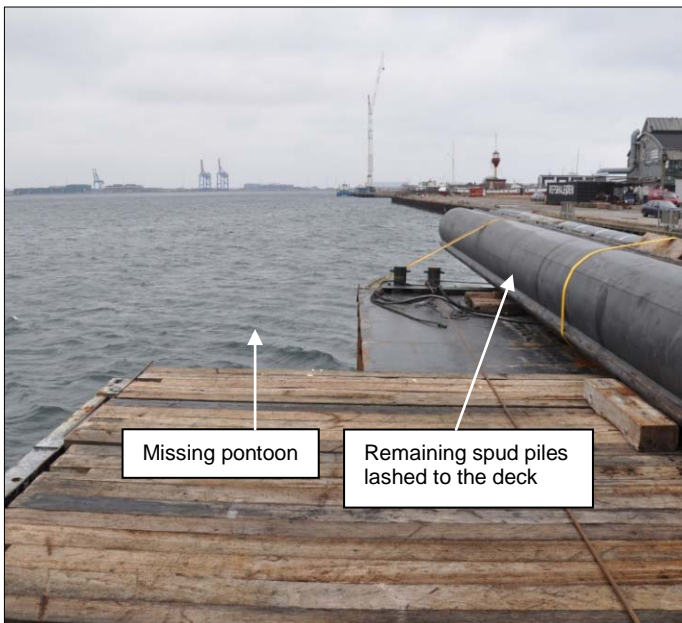
Figure 10: Missing pontoon
Source: DMAIB

The position of the missing pontoon on the barge is seen in figure 10 below. Figure 11 shows a picture of the hydraulic jack-up unit. The forward spud pile seen on figure 11 below was broken off immediately under the jack-up unit approximately 25 metres from the bottom end.

The pontoon containing the hydraulic jack-up unit and spud pile had broken off and the dovetail elements had been deformed. The aft spud pile, still attached to the pontoon, was bent approximately 4.5 metres from the bottom end. A crack where it was bent enabled the spud pile to be filled with water, thereby losing its buoyancy.

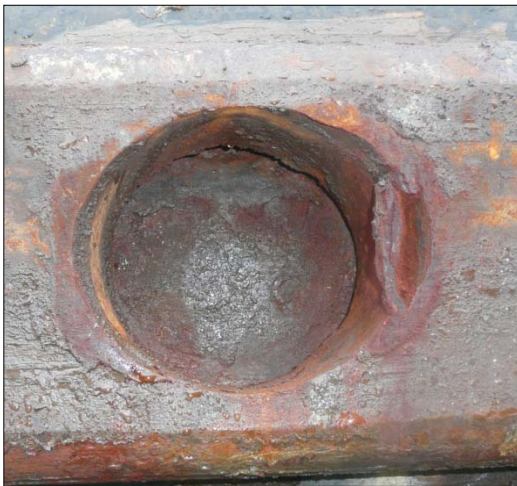
Figure 12: Oval guide hole on retrieved spud pile
Source: DMAIB

Figure 12 below is a picture of one of the holes in the guide of a retrieved spud pile. The holes in the spud pile guides were, to varying degrees, worn and had become oval. The fact that all the holes were worn to varying degrees indicates that the wear did not originate from the accident.

The wear on the locking pins and holes in the guides on the spud piles, making them conical, was created over a long period of time and was not acknowledged and acted upon during the survey from classification society and general maintenance of the barge.

The Danish Maritime Accident Investigation Board recommends that the owner of AARSLEFF JACK III, in co-operation with the manufacturers of the barges, supplies the barges having no operational manuals with suitable manuals that cover the subject areas already included in the existing manuals for other barges within their fleet. Furthermore, it is recommended that the owner, in co-operation with the relevant classification society and manufacturer, reviews the scope and method of the maintenance and check of the jack-up units.

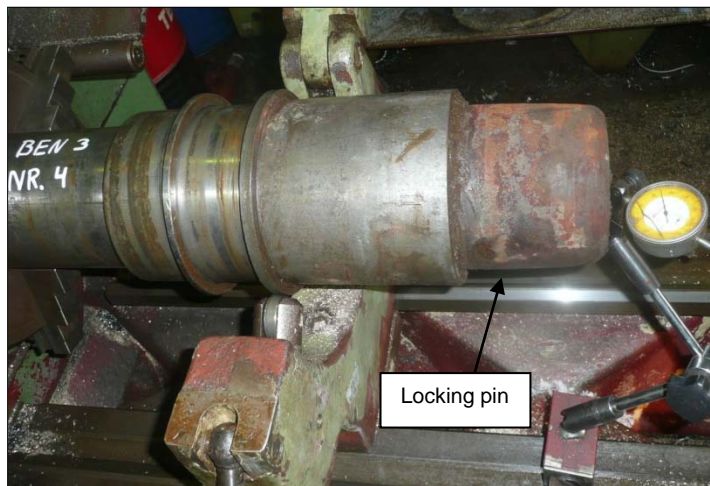
Figure 13: Locking pin
Source: DMAIB

Figure 13 below is a picture of one of the locking pins. Measurements were made of all the locking pins on the hydraulic jack-up unit (except on the traverse that was not retrieved). These measurements indicated that the pins had suffered considerable wear that was not of a recent date and that had, therefore, been created over a long period of time.

The wear varied from 4 mm to 17 mm and had left the pins with a conical shape as opposed to the original cylinder shape. Furthermore, all the locking pins had been bent up to 5 mm in a downward direction.

It has not been established for certain what technical circumstances caused the malfunction of the locking pins, thereby enabling the spud piles to come loose and slide out of the hydraulic jack-up unit. However, the wear of the locking pins and guide holes, the lacking securing of the spud piles and the area and conditions under which the barge was towed are factors that most likely contributed to the breakdown.

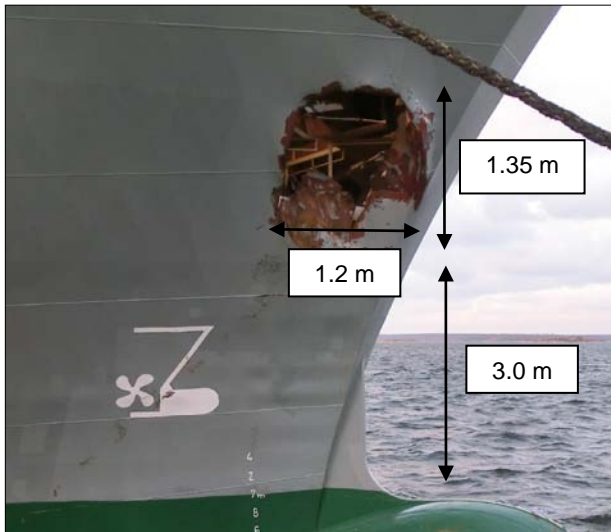
Figure 14: Hole in starboard bow
Source: Reederei H.-G.Vöge GmbH & Co.KG

The hole in the starboard bow measured 1.2 metres high by 1.35 metres long. It was of a regular elliptical shape. The location of the hole is shown in figures 14 and 15 below.

The plating around the edge of the hole showed characteristic 'petalling' indicating that the plating had been penetrated from the outside. There was evidence of dark coloured paint residues of a colour different to that of the hull. Samples of these were collected for analysis.

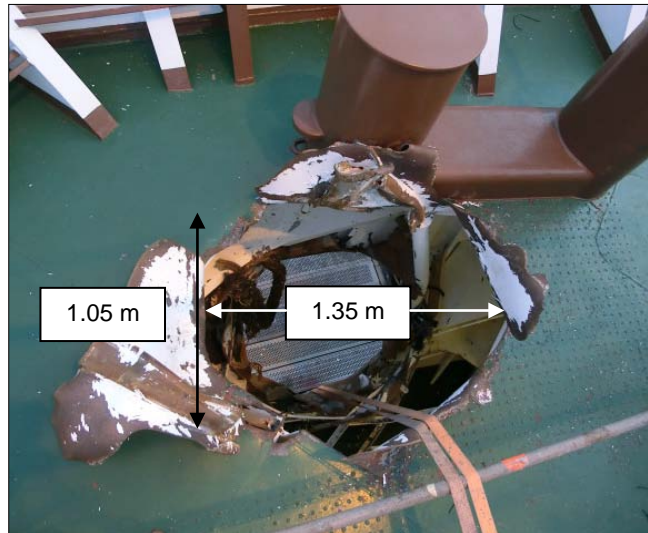
Figure 15: Hole in forecastle deck
Source: Reederei H.-G.Vöge GmbH & Co.KG

The damages to JOHANNA were confined to the forecastle/starboard bow area. Both holes were above the waterline and there had been only minor ingress of water. Nevertheless, the damage was considerable, penetrating the 10 mm thick deck plating.

Overall the damage caused by the impact was substantial, shearing through two substantial steel structures leaving two large, almost circular holes.

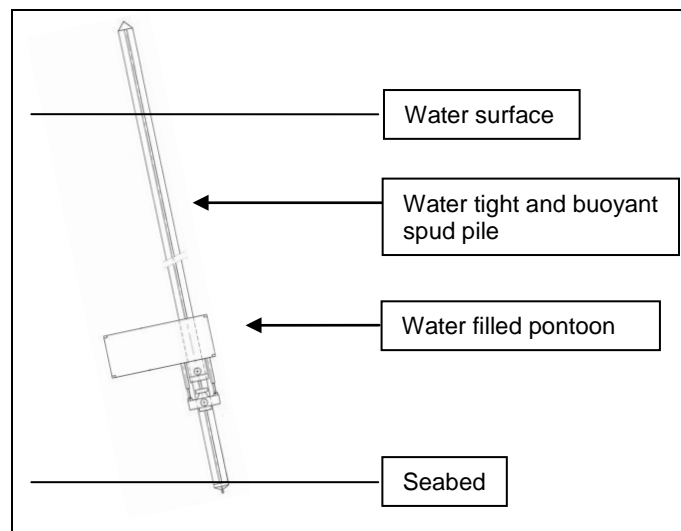
Figure 17: Spud pile on seabed
Source: DMAIB

As time passed, the increasing severity of the sea conditions and the movements of the loose spud pile created forces beyond the limits of the pontoon and dovetail elements. The pontoon's dovetail elements broke off tearing the metal plating. The pontoon got filled with water in the process and sank. The spud pile was still intact and the buoyancy of the spud pile turned it upside-down leaving the top part with the pontoon on the seabed and the other end above the surface.

The water depth on the location where it was found is about 20 metres and the spud pile is 32 metres long. This left a considerable part of the spud pile above the surface dependent of the angle of the spud pile, see illustration of a likely scenario on figure 17 below.
